Aesthetic metal ceramics: it's what you make of it!

Renato Carretti describes three challenging cases that were solved with a metal-ceramic solution

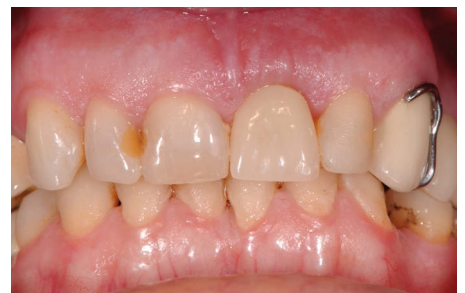
Figure 2: Clasp-retained provisional restoration to replace tooth 21 and for the preparation of the papilla in order to guarantee a harmonious gingival contour

Following extraction, the provisional restoration with clasps/clamps was seated and the gingival papilla was prepared prior to implantation in order to ensure subsequent harmonious progress (Figure 2). After the seating of the implant, sufficient time was left for the gingiva to regenerate, and is in a perfect condition after healing (Figure 3).

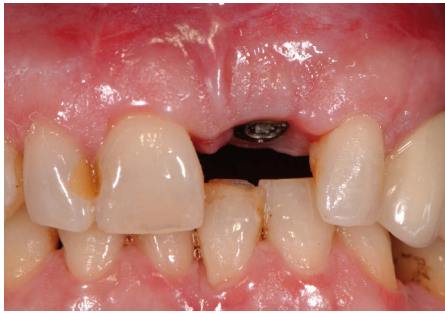
Figure 3: Perfect gingival papilla after healing of the implant

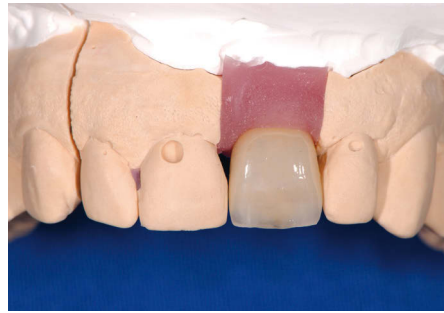
Figure 4: It cannot be assessed on the basis of the model situation whether the ceramic reconstructions will match the rest of the oral cavity in shape, shade and transparency

A decisive factor for the assessment of the correct degree of transparency, however, was not the situation on the model (Figure 4), but the intra-oral try-in. The clasp-retained provisional restoration was removed, and the screw-retained restoration provisionally attached (Figure 5). Only now can a realistic assessment be made as to whether the restoration suits the oral environment (Figure 6).

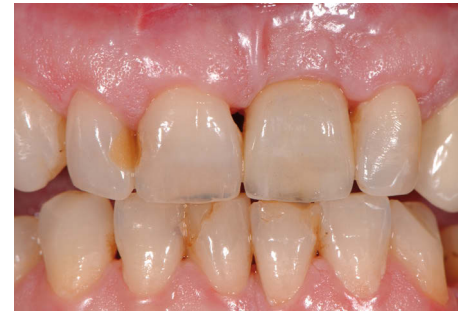
Figure 5: The same crown as shown in Figure 4 shows its natural appearance only after the intraoral try-in. It shows the same degree of transparency as the neighbouring natural tooth 11

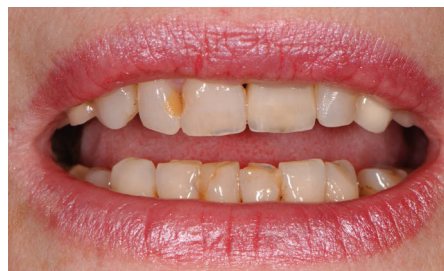
Figure 6: Not easy to recognise at first glance as a dental restoration. The crown matches its environment

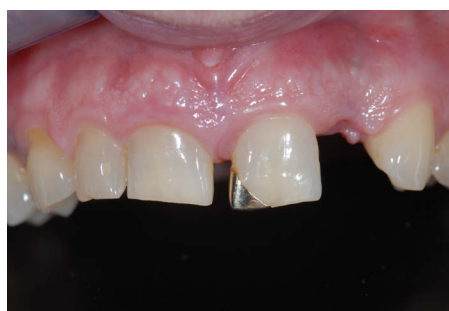
Figure 8: Excellent gingival situation after the healing of the implant replacing tooth 22; the gold filling on tooth 21 has become an indispensable, characteristic feature of the patient's dentition

In the case of a female patient aged around 65 years old, tooth 22, which was fractured down to the root, was extracted and an implant seated in its place. She already had a gold filling in tooth 21 for around 45 years, and could not imagine her appearance without this. Although the gap following implantation was not provisionally restored, the gingival situation was excellent – which is not simply a matter of course at her age

(Figure 8). For both dentist and dental technician, therefore, these were good conditions for successful treatment. In the case of the intra-oral try-in, the crown showed good results cervically with regard to the gingival situation, and a good fit and shade match were obtained straight away.

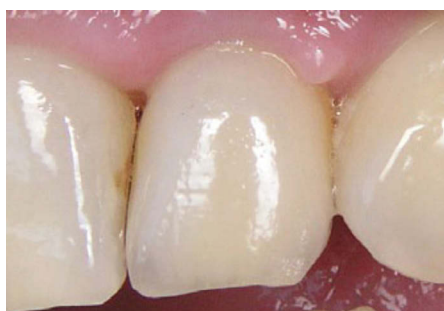
Figure 9: A good match of the crown replacing tooth 22 at the try-in. The surface shows the same matte glaze as the adjacent natural teeth after manual polishing

It is not possible to recreate the surface of a veneer so that it resembles a natural tooth by means of a glaze firing alone. For this reason the glaze firing was followed by manual polishing with pumice powder and a hand-brush. The result was a matte glaze (Figure 9). This generally takes around 5-10 minutes, but with a little experience the surfaces will look considerably more natural than with any glaze firing: the finer the structure of the ceramic (in this case VM 13/VITA Zahnfabrik), the more natural the result of polishing will look. Care is required with surface-stained veneers: in the case of excessively intensive polishing, the shades may be 'polished away'.

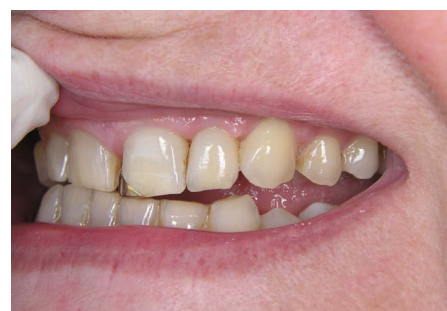
Figure 10: Healthy gingival papilla after three months in situ

After finishing and screwing the restoration onto the implant, the excellent gingival situation became evident, which was still intact at the recall visit of the patient three months later (Figure 10).

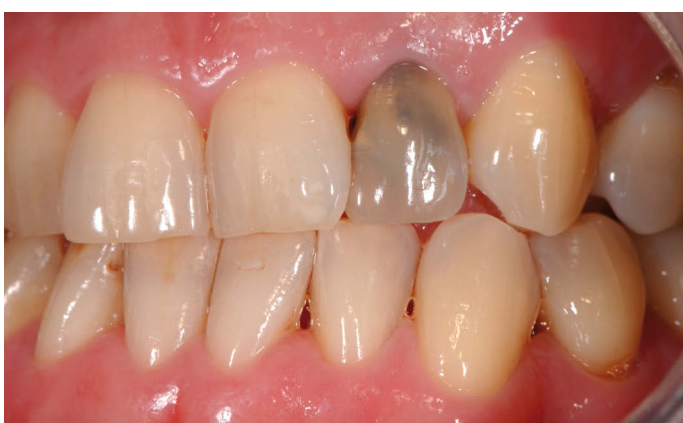
Figure 11: Situation before treatment showing devitalised tooth 22 with dark discolorations

A patient aged around 45 years old presented at the practice with a devitalised tooth with dark discolorations (Figure 11) – an absolutely classical case for a metal-ceramic restoration. The strongly discoloured tooth stump would show through an all-ceramic restoration and make the veneer look grey.

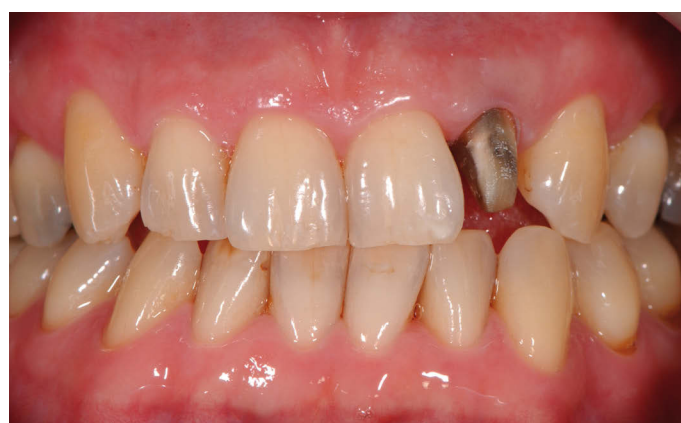
Figure 12: Characteristic features such as enamel cracks, mamelons and decalcification marks on the adjacent tooth 21

With this veneer (VM 13 VITA Zahnfabrik), the goal was to reproduce numerous small enamel cracks, mamelons and decalcification marks like those that characterised the adjacent tooth 21 (Figure 12). After the first firing, Interno 1 (white smoke) was inlaid for the small enamel cracks, and Interno 2 (sand) was used to emphasise the mamelons. Akzent 17 (Niagara) was

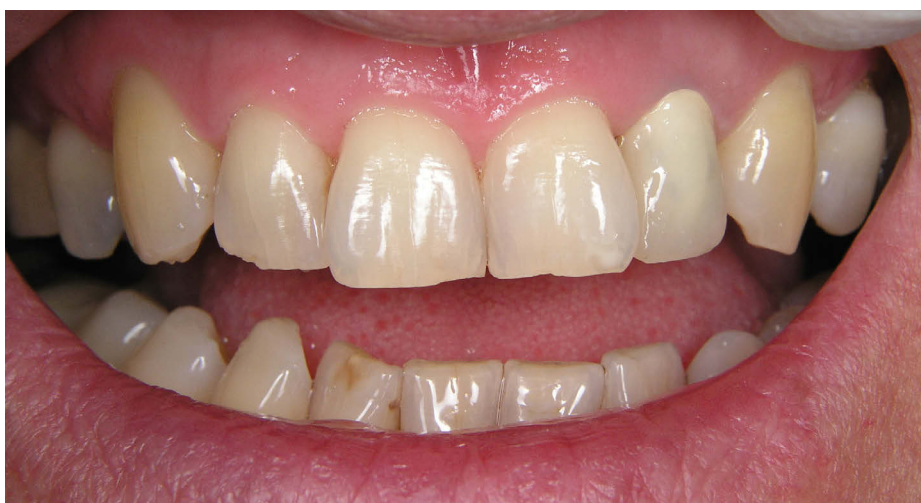
Figure 13: Provisional restoration with an acrylic resin crown

applied in order to emphasise the bluish glaze in the incisal edges, and a glaze firing performed. Already with the provisional restoration a dark shadow became visible below the gingiva (Figure 13), which remained after completion and seating of the crown (Figure 14). This was probably due to the dark interior of the crown being reflected in the natural tooth substance, and continued as a grey shimmer in the gingiva. After manual polishing, the surface of the veneer showed the same texture as the neighbouring tooth (Figure 14). A harmonious match was obtained with the patient's natural dentition, and was not recognisable as a dental restoration (Figure 15).

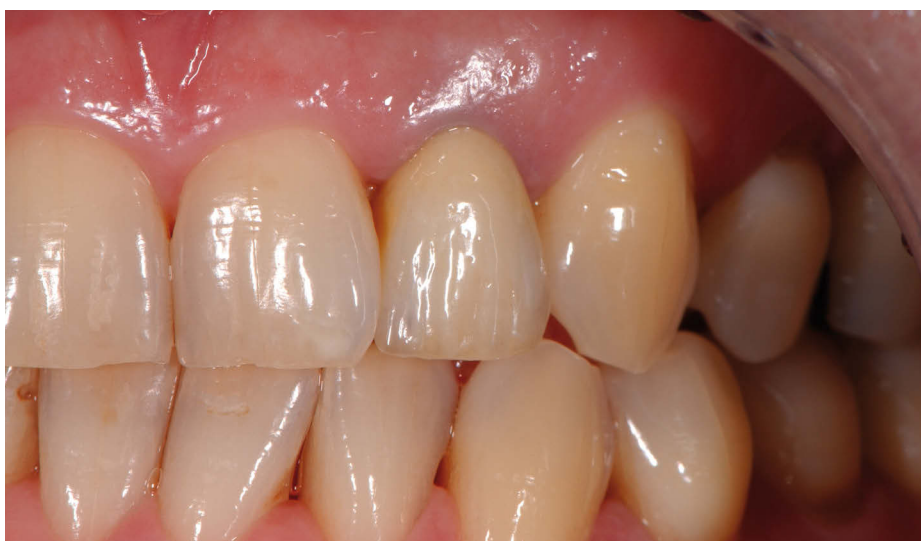
Figure 14: Replication of the surface structure analogue to the adjacent tooth 21, grey shadow beneath the gingiva

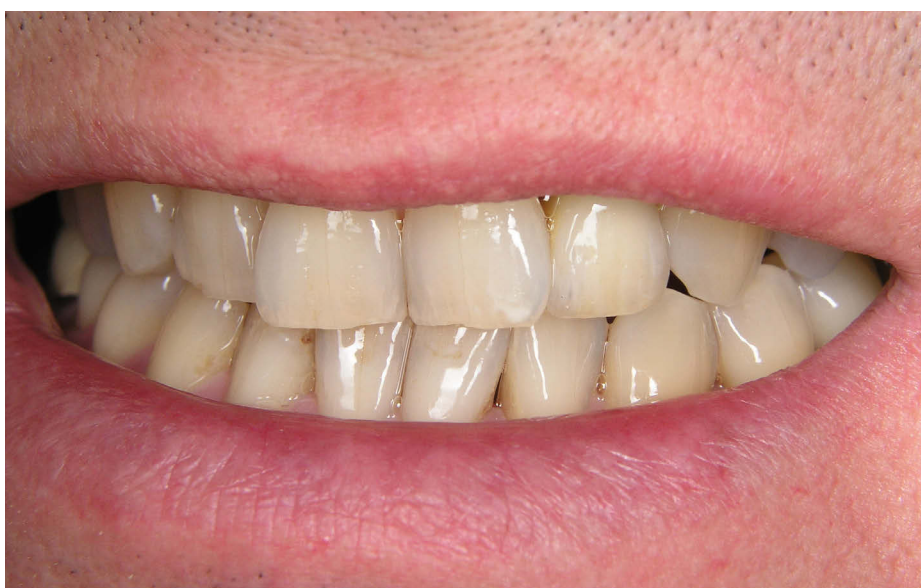
Figure 15: Harmonious match of the crown with its surroundings, has a completely natural effect
